# SAFETY ALERT

## • *Use of chain flail/non standard accessories on brush cutters*

**KEY ISSUES:** NON-STANDARD METAL BRUSH CUTTING ACCESSORIES FITTED TO PETROL DRIVEN BRUSH CUTTERS CAN FAIL CATASTROPHICALLY IN-SERVICE. THERE IS A RISK OF DEATH OR SERIOUS INJURY TO OPERATORS AND OTHERS IN VICINITY FROM EJECTED METAL COMPONENTS. THESE ACCESSORIES ARE MANUFACTURED FROM MORE THAN ONE COMPONENT AND ROTATE AT HIGH SPEEDS ANYONE USING THEM SHOULD DISCONTINUE USE OF ANY NON-STANDARD METAL CUTTING ACCESSORY IMMEDIATELY AND CONSULT THE BRUSH CUTTER MANUFACTURER FOR GUIDANCE.

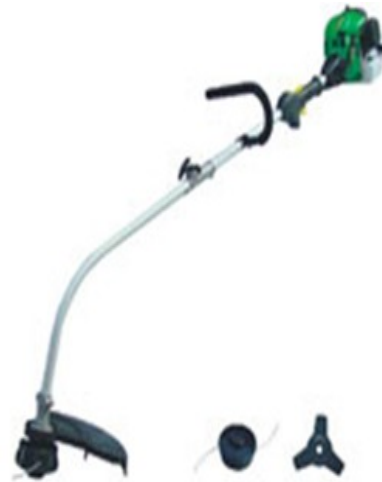
Photograph of brush cutter with typical manufacturers' cutting attachments

Manufacturers' advice should be followed as to the appropriate combinations of cutting tools and guards. Such advice is typically available within the instruction books accompanying the machine.

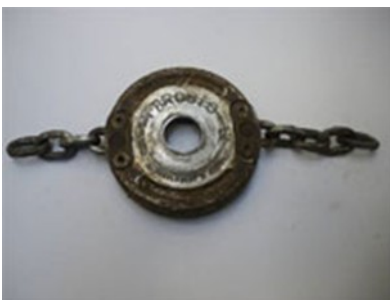
**THE SAFETY ALERT ARISES FROM A FATAL INCIDENT. INITIAL INVESTIGATIONS INDICATE THAT A LINK FROM A CHAIN FLAIL ATTACHED TO A BRUSH CUTTER, STRUCK A NEARBY WORKER IN THE HEAD.**

Chain flail attachment with two chains

The fatal incident involved the use of a twin-chain attachment, similar designs have been encountered having 4 chains, and one which utilises chainsaw type chains as the cutting implement. The presence of a CE mark should not be regarded as a reliable indication that such at-

Any brush cutters fitted with chain flail or similar non-standard attachments should be taken out of service immediately and the attachments removed and replaced with the manufacturer's approved accessory.

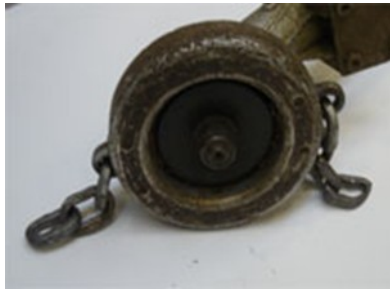
In contrast with dedicated chain flail machinery, brush cutters typically lack the robust guarding arrangements required to control the risk from articles (including fragments of chain) being ejected with high energy. The guarding supplied with brush-cutters is predominantly aimed at protecting the operator from inadvertent contact with the cutting accessory.

Flail attachment fitted to the brush cutter

Manufacturers' original cutting equipment such as nylon cords, metal cutting blades and saw blades are designed to be used in combination with specifically designed safeguarding systems. The chain flail attachments are not supplied with any compatible safeguard/deflector.
